EZVFSD Installation instructions

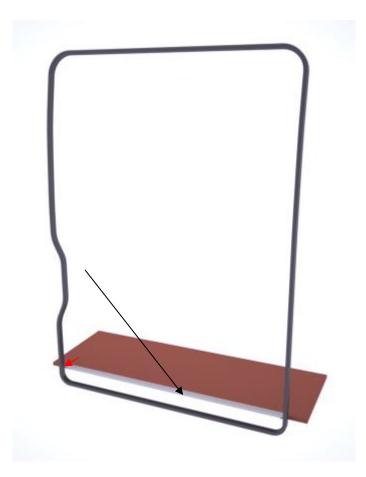
- 1) 4 pcs 3,5x16mm sunkhead screws to fix the bottom profile (Yellow)
- 2) 2 pcs 2,9x9mm sunkhead screws to fix the cassette (Blue)
- 3) 2 pcs 2,9x9mm sunkhead screws to fix the sliderclamp (Red)
- 4) 2 pcs 3,5x16mm panhead screws to fix the cassette to the interior (Purple)

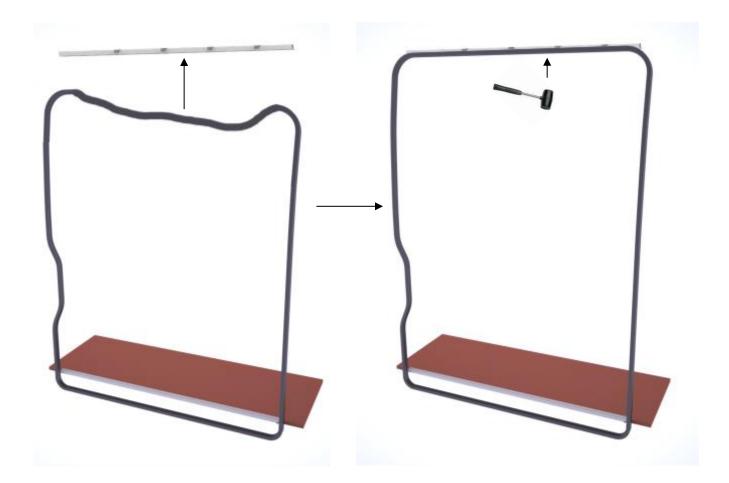
b. Put the metal clips on the metal edge on the body of the van.Insure that the clips are fully seated!

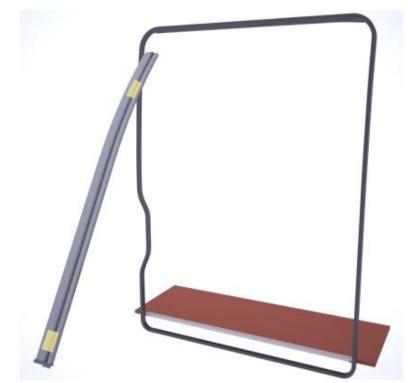
- 5) a. Put the door rubber back in place over the clips.
 - b. Reseat the door rubber with a soft rubber mallet.

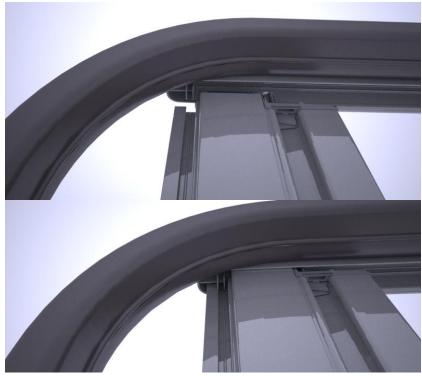
6) Take the cassette and pullbar assembly and make sure to leave on the packaging tape to hold the assembly together during installation.

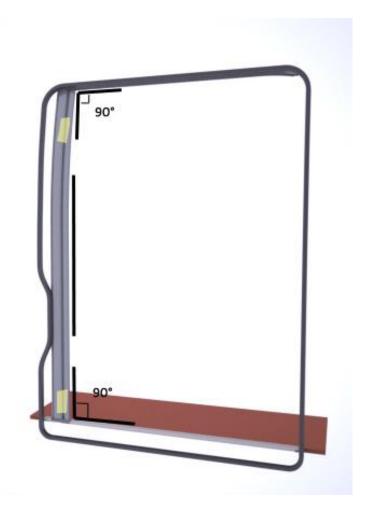
8) Check cordpath of the top slider!

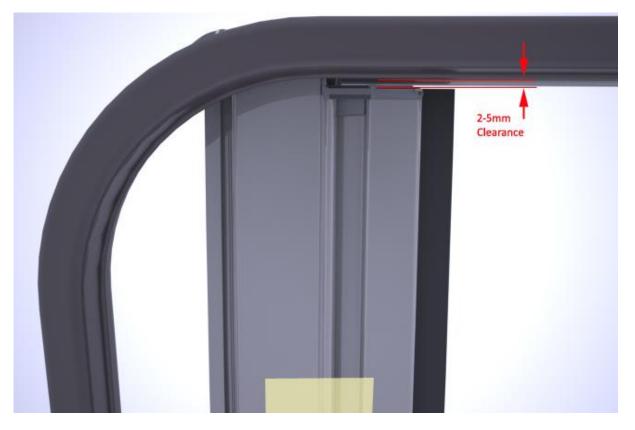
13) Fix the sliderclamp to the slider with 2 pcs of 2,9x9mm sunkhead screws.Care should be taken in case powertools are used to install the smaller screws, this will prevent damage to the screwchannels.

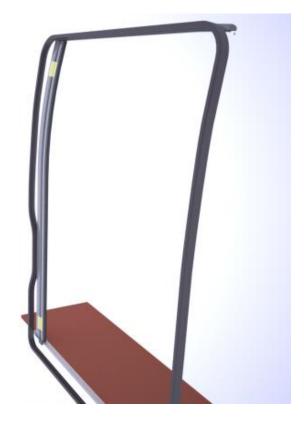
15) Fix the cassette to the interior or object connected to the vehicle body using the 2 pcs 16x3,5mm panhead screws.

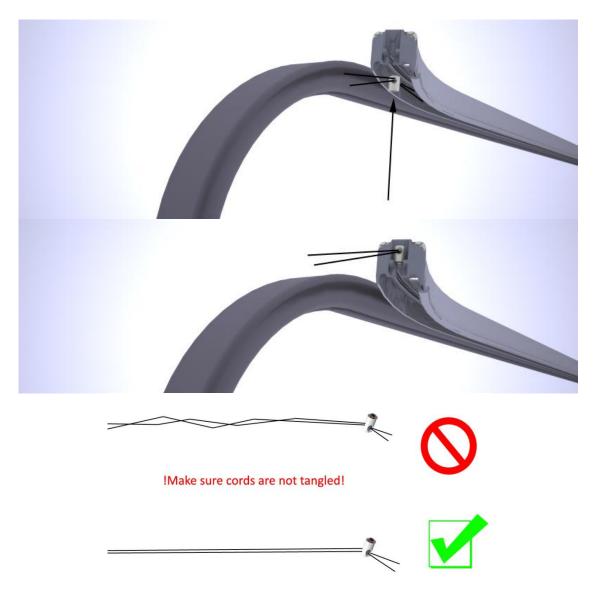
18) Check cordpath of the sliderclamp and cordtensioner.

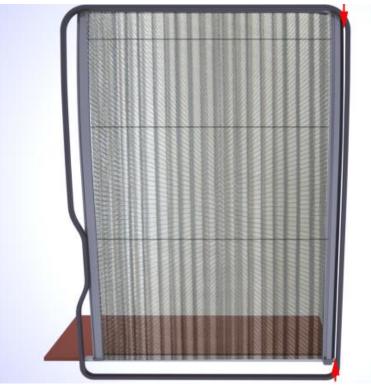
23) Check if the pullbar is aligned with the doorrubber when sliding the pullbar to the front of the vehicle to enable a good sealing effect.

In case the pullbar is not aligned properly please repeat step 22.
